SERVICE BULLETIN # 2

SPARTAN AIRCRAFT COMPANY

MODEL 7W EXECUTIVE

SPARTAN AIRCRAFT COMPANY
SERVICE BULLETIN #7

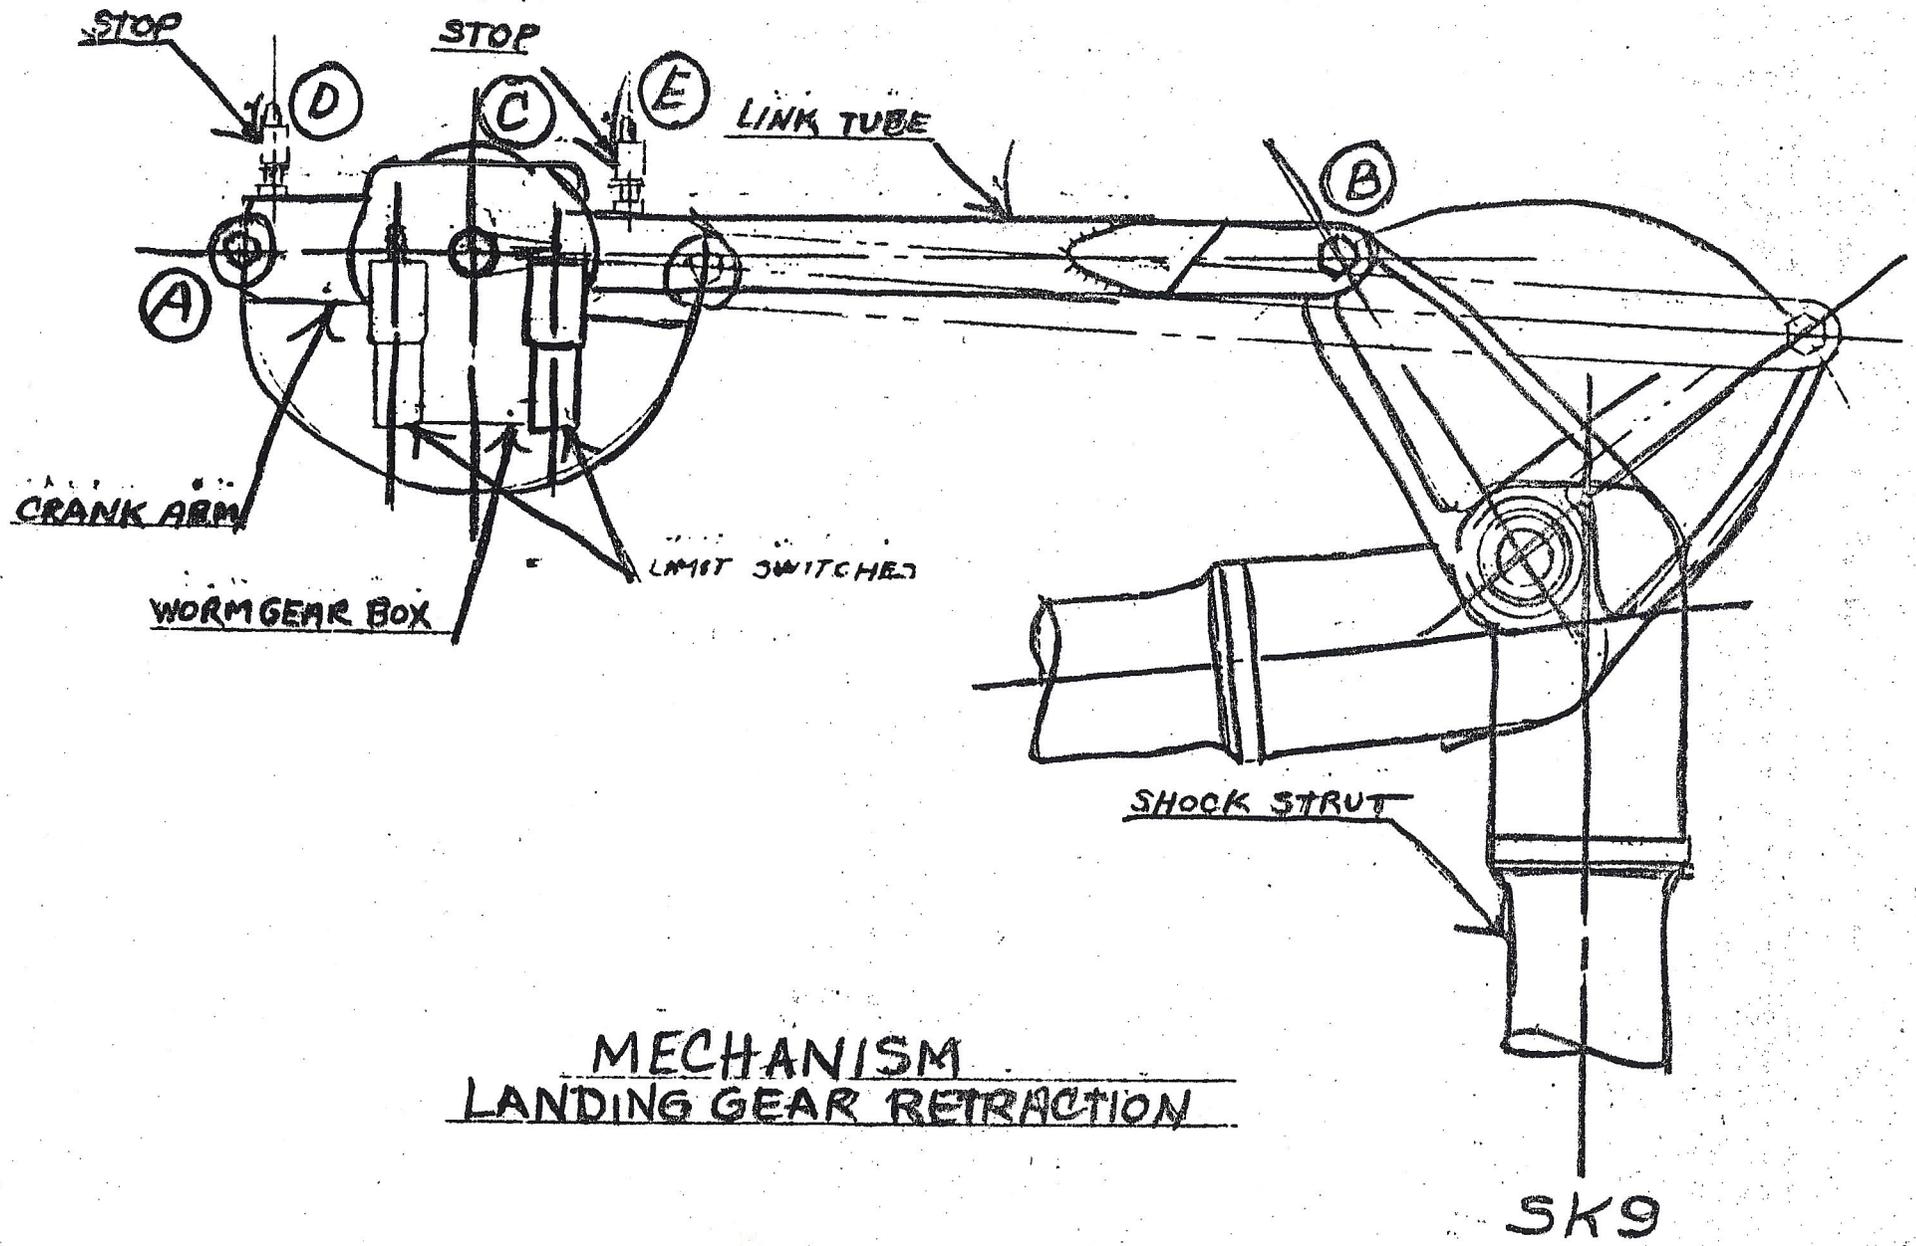
Crank the gear up by hand until the centers of "A", "B" and "C" are in perfect alignment with each other. When these three points are in alignment with each other. When these three points are in alignment, run Stop "E" down until it contacts crank arm. Crank gear down by hand until "A", "B" and "C" are again in perfect alignment with the gear down and run Stop "D" down to crank arm. Now operate gear by electric motor adjusting the limit switches by sliding them up or down in the brackets that support them so that the crank arms will come to rest against the stop without a jarring force of any kind, both in the Up and Down positions. Recheck the struts to see if they are still in the proper vertical position with gear down.

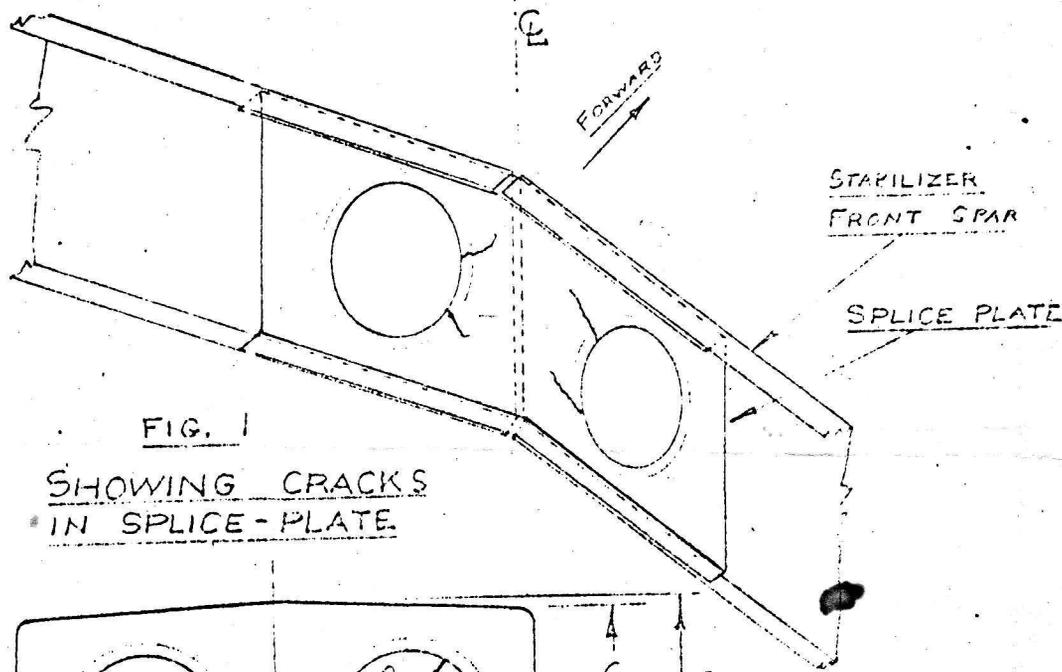
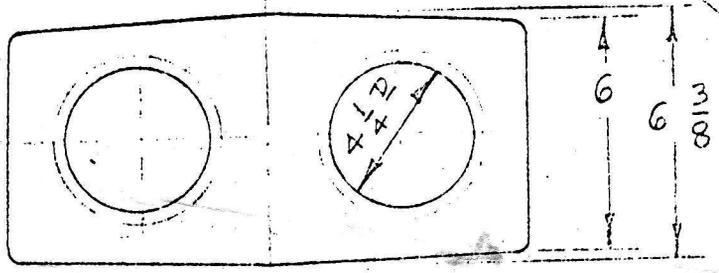
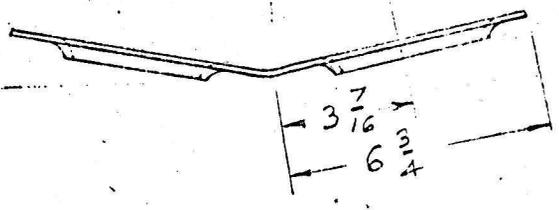
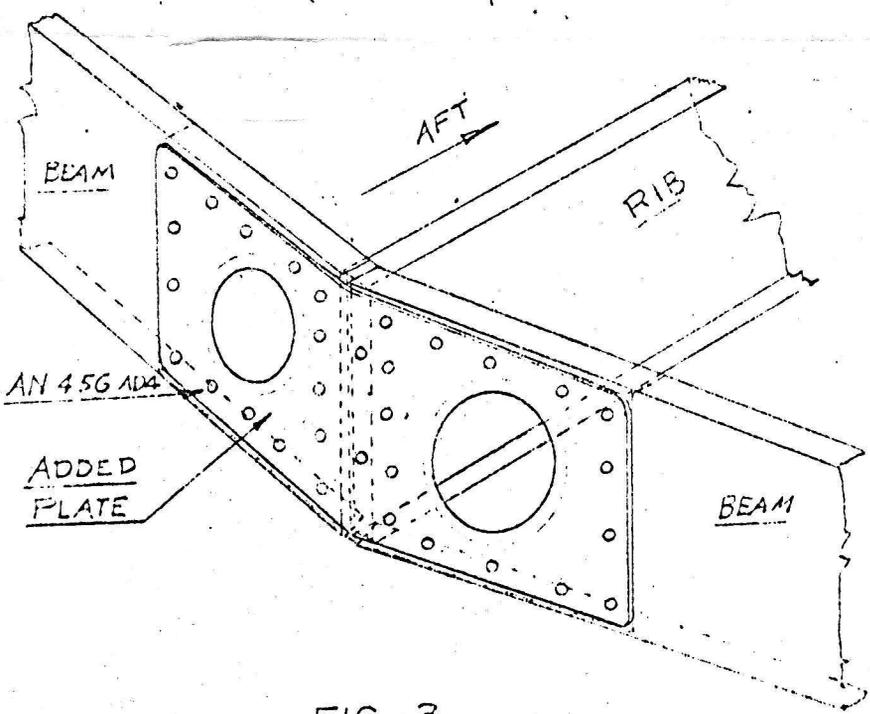
Cracks have been found at the edge of the lightening holes of the splice-plate which joins the stabilizer front beams together at the center-line of the stabilizer.

If cracks are found, drill stop-holes at end of cracks and add a reinforcing plate of 0.040 24 ST aluminum alloy with flanged lightening holes, (see sketch) to the forward side of the stabilizer spar, picking up the original rivet pattern and an extra row of rivets on each side of the center-line of the stabilizer using AN 456 AD 4 rivets. Repair can be made by removing tab drive mounting bracket plate at fuselage Bulkhead No. 9, and working through aft end of fuselage without removing stabilizer from the airplane.

.040
24 ST
AL. AL.
